# PROJECT HIGHLIGHT

## PORT OF TEXAS CITY, SE TEXAS RAIL MAINTENANCE TEST SECTION

### BALLAST PRESERVATION

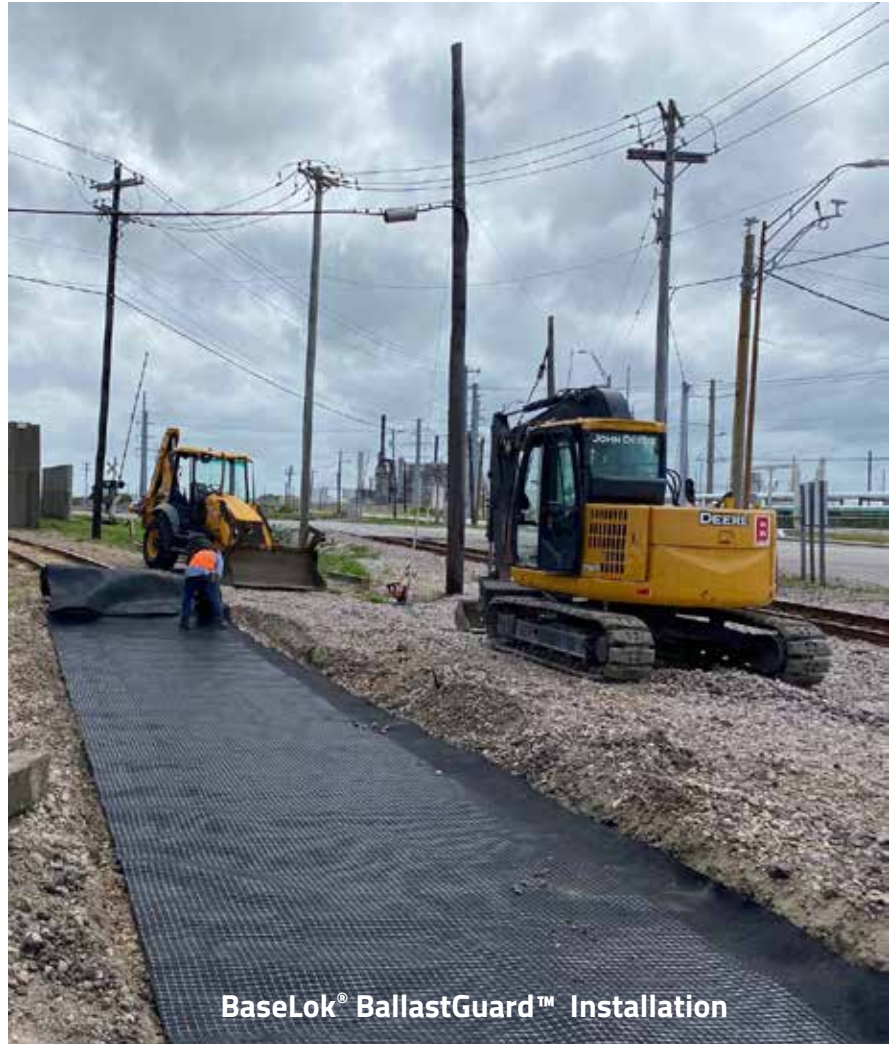
BaseLok® BallastGuard™ Installation

For our port/rail facility project, construction crews undercut the track sections, repaired the subgrade, and then placed the **BallastGuard™** material in each of the repaired sections. The placement of the **BallastGuard™** in these problematic areas protected each of the repaired sections from future pumping of fines into the subgrade, and preserved the ballast integrity.

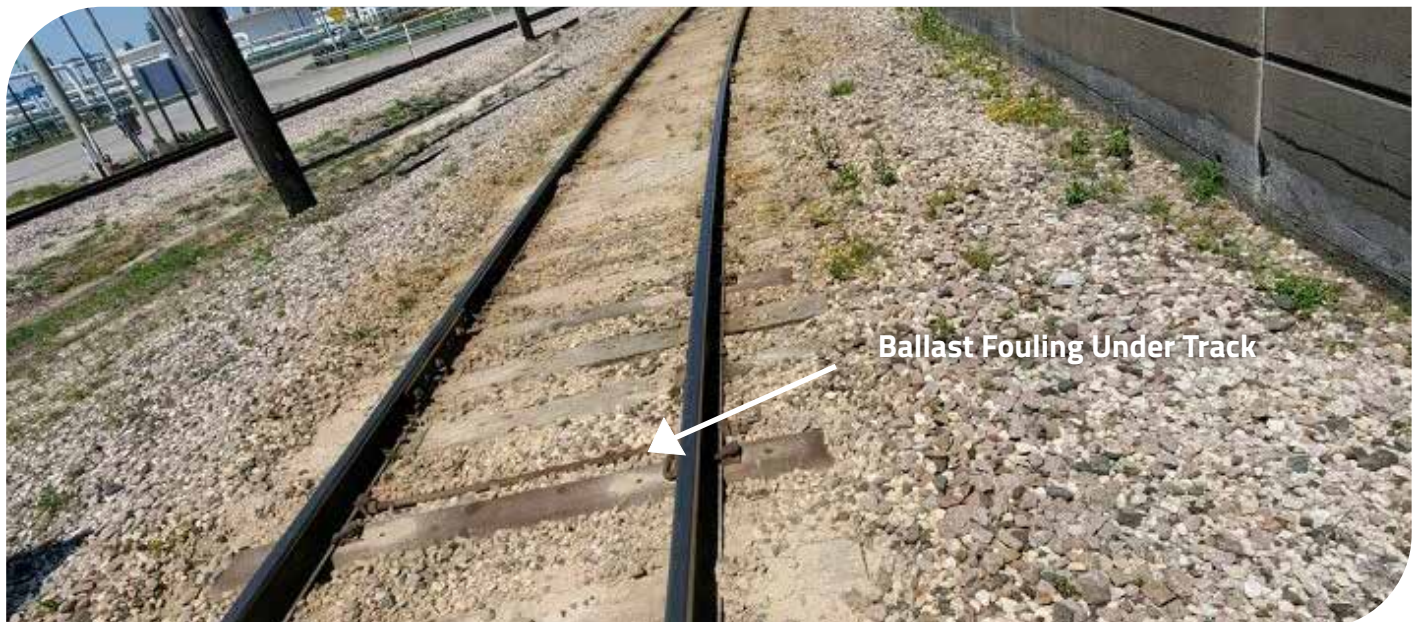
Ballast Fouling Under Track

A port facility with more than 10 miles of rail in Southeast Texas needed to address ballast that had been contaminated with fines from the subgrade. This problem known as ballast fouling, is common in areas with high silt contents and high water tables.

Ballast fouling is an issue that is challenging for rail owners to deal with throughout the United States and the world. It is caused by the pumping action created when railcars repeatedly pass over railways built over weak and saturated soils. Sites located at port facilities, oftentimes experience saturated soil subgrades, due to their proximity to water. The subgrade typically remains saturated and when the dynamic weights of loaded rail cars pass over these areas, water jets up (pumps) into the clean subballast and ballast. This water causes degradation of the subgrade with fines contaminating the subballast, thus weakening the subballast and ballast stone resulting in failures. This degradation eventually leads to potentially causing track systems to fail prematurely. As such, routine maintenance in these areas is required and often at a much higher frequency. These maintenance costs are detrimental to all rail operations.

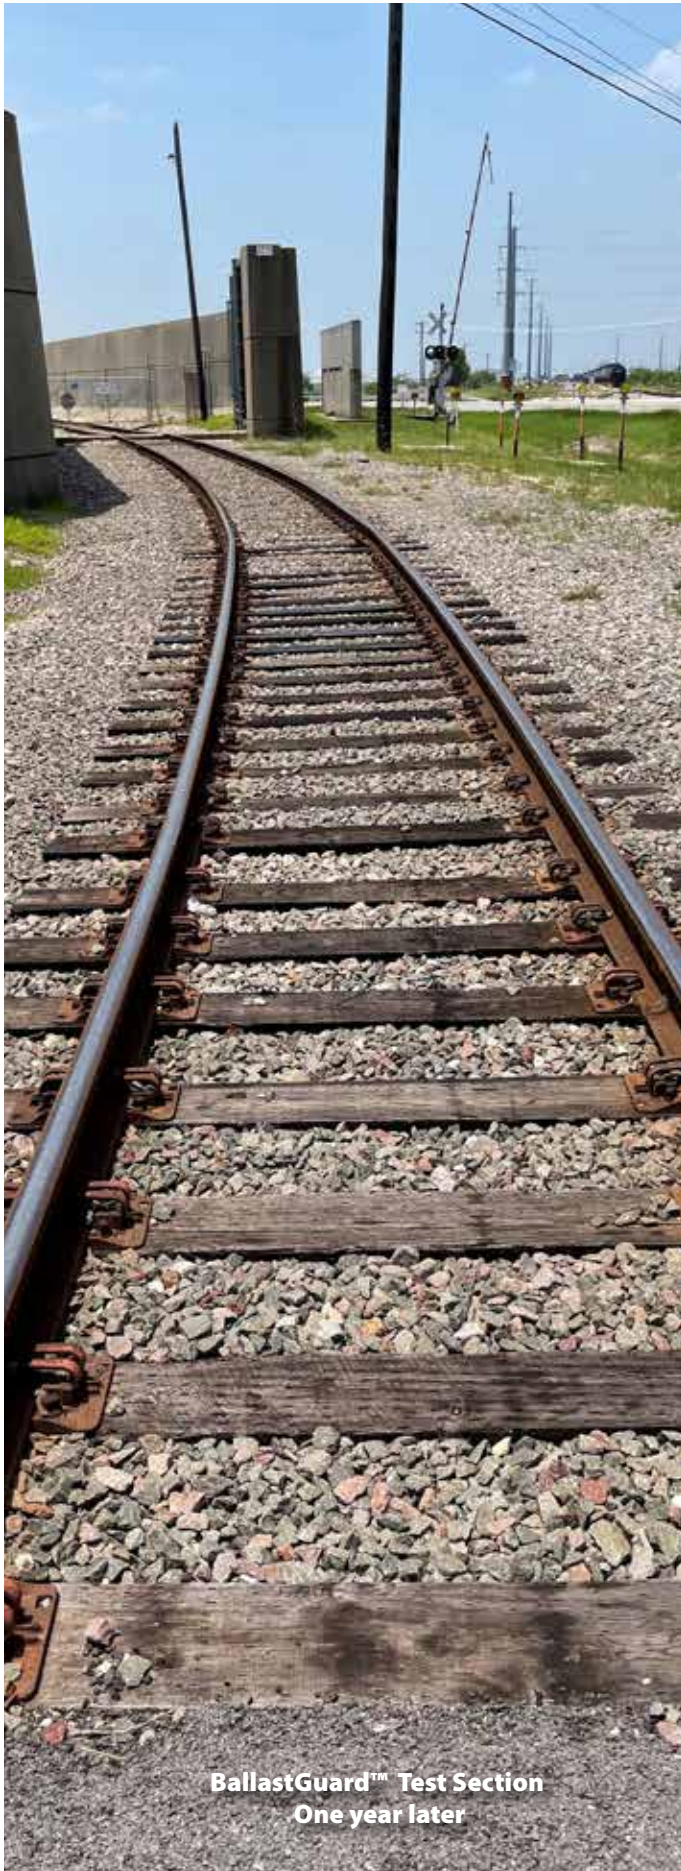
BallastGuard™ Test Section  
One year later

The port manager at this facility has been extremely impressed with the performance of the **BaseLok® BallastGuard™**. This particular test section was installed early May, 2021, and no additional maintenance has been required in any of the repaired sections. Ballast preservation has been achieved in all locations where **BallastGuard™** was installed. The port plans to incorporate **BaseLok® BallastGuard™** whenever additional maintenance is needed, and will specify **BallastGuard™** on all future expansion projects.
